Emergency Levee Erosion Repair Project

**Don Kurosaka
DWR Project Manager**

February 2007

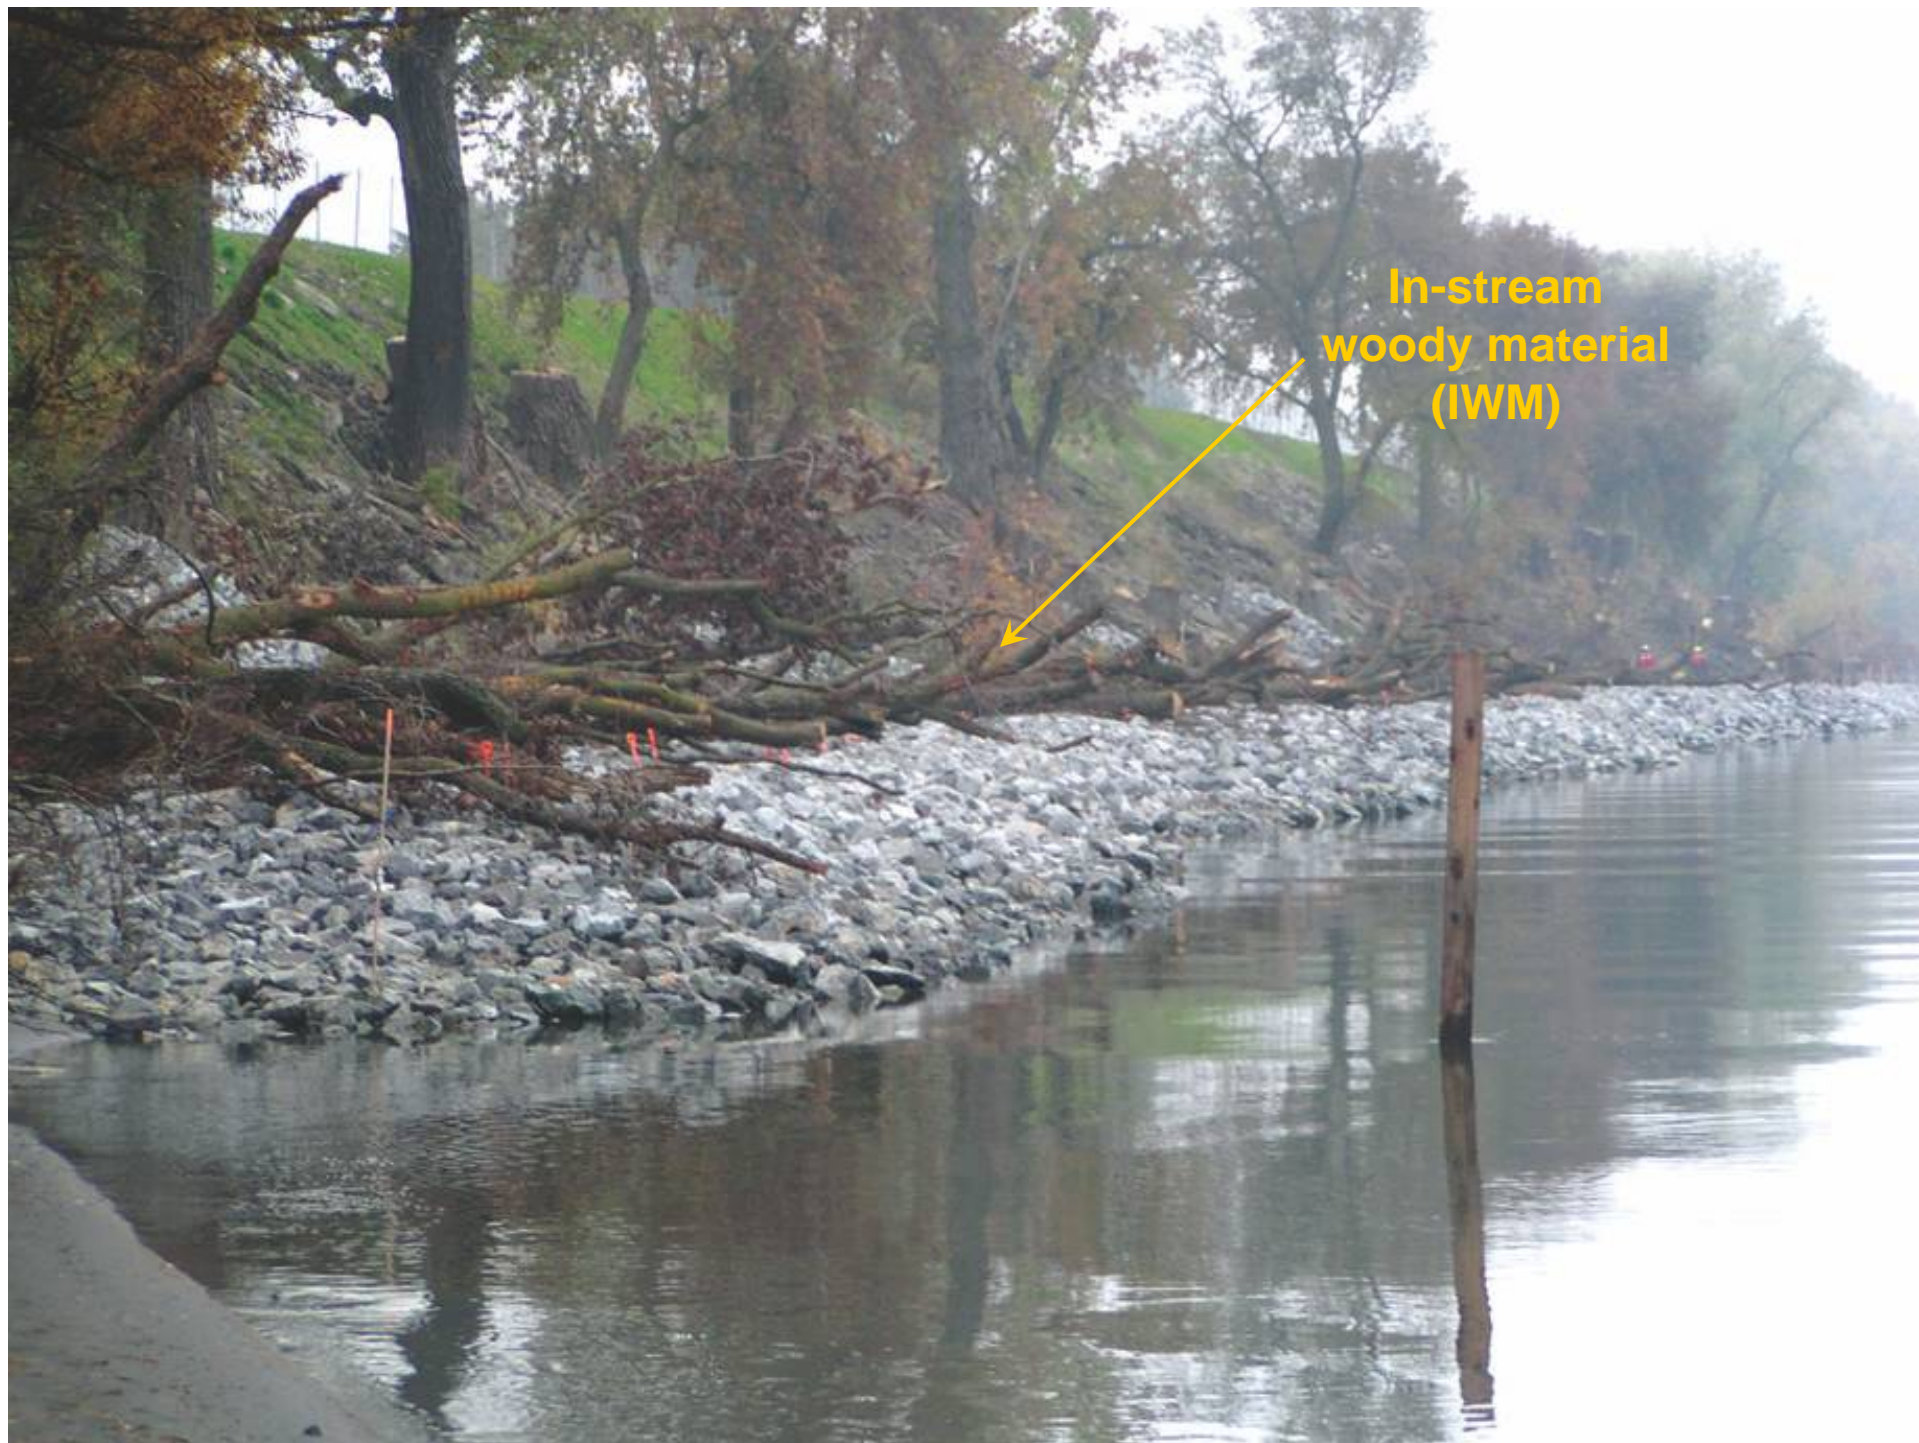
Typical Repair Section

- 33 critical erosion sites
 - 15 sites land accessible
 - 18 sites land and barge accessible
- 5 miles of bank protection (29 sites)
- 4000 ft of set-back levee (4 sites)
- 1,400,000 tons of rock material
- 200,000 cy of earth fill
